LOCAL HERITAGE LIST

NOMINATION FORM

Name of building, structure or feature (if any) Well Cap and Pump

Address/Location Village Green, Christleton

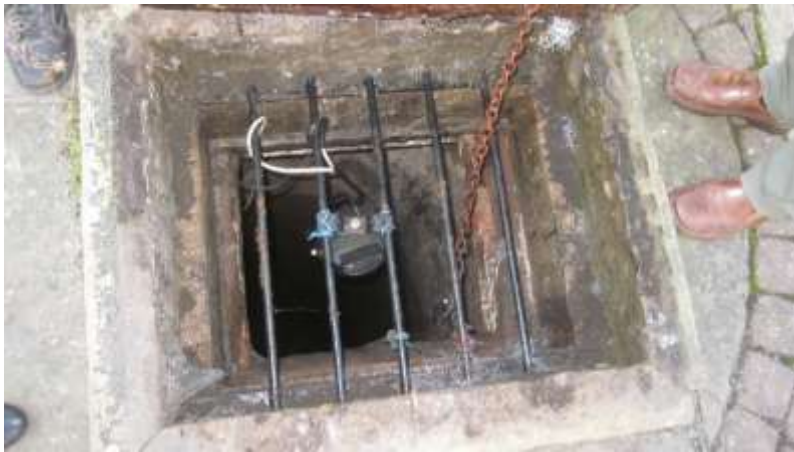
The circle in the paving is directly over the well shaft.

The date of excavation of the shaft is not known, but it is 5 ft diameter, cut through the sandstone rock and is 62 ft deep – when checked in 1995 it contained 23ft of water. The well is capped by a rough brick and sandstone arch which was reinforced with a concrete slab in 1995 for safety, at the request of Cheshire County Council Highways Dept. The slab is now covered with stone paving showing the well shaft position – an access opening in the paving is covered in an oak lid. Below the paving is a duct linking the well to the adjacent memorial shelter (listed) which housed a pump for a few years at the end of the 19<sup>th</sup> Century There is a light in the shaft, linked to the street lighting control. The renovation work in 1995 was done in conjunction with the Chester City Conservation Officer.
